INDOOR AIR QUALITY ASSESSMENT

**Berkshire Community College
Koussevitzky Arts Center
1350 West Street
Pittsfield, MA**

Prepared by:
Massachusetts Department of Public Health
Bureau of Environmental Health
Indoor Air Quality Program
May 2017

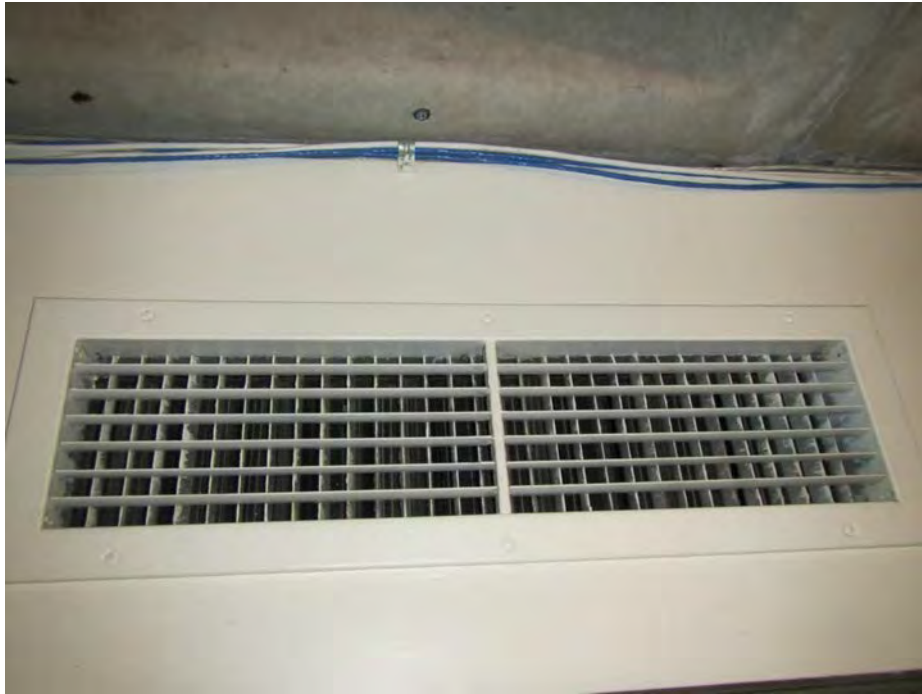
Picture 1

Most areas of the KAC do not have mechanical ventilation and instead rely on natural ventilation through open windows and doors. The testing room (K213) and the adjunct faculty space (F202) were both equipped with supply and exhaust ventilation (Pictures 1 and 2). The testing room supply ventilation appeared to have weak flow. BCC facilities staff noted a hole in the ductwork that supplies this area and reported that they plan to repair it.

Supply air diffuser in Testing Room (K213)

3. Continue with plans to repair the hole in the supply ventilation ductwork leading to the testing room (K213).
4. Consider consulting with an HVAC design engineer to install building-wide mechanical ventilation in the KAC.

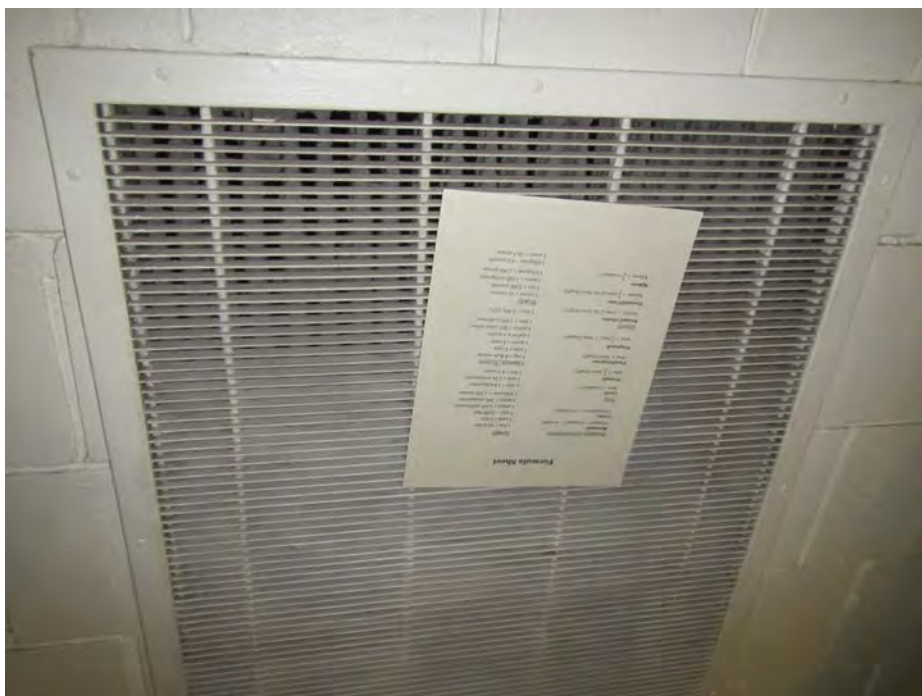
Picture 2

Wall-mounted return vent in (K213)-paper shows it drawing effectively

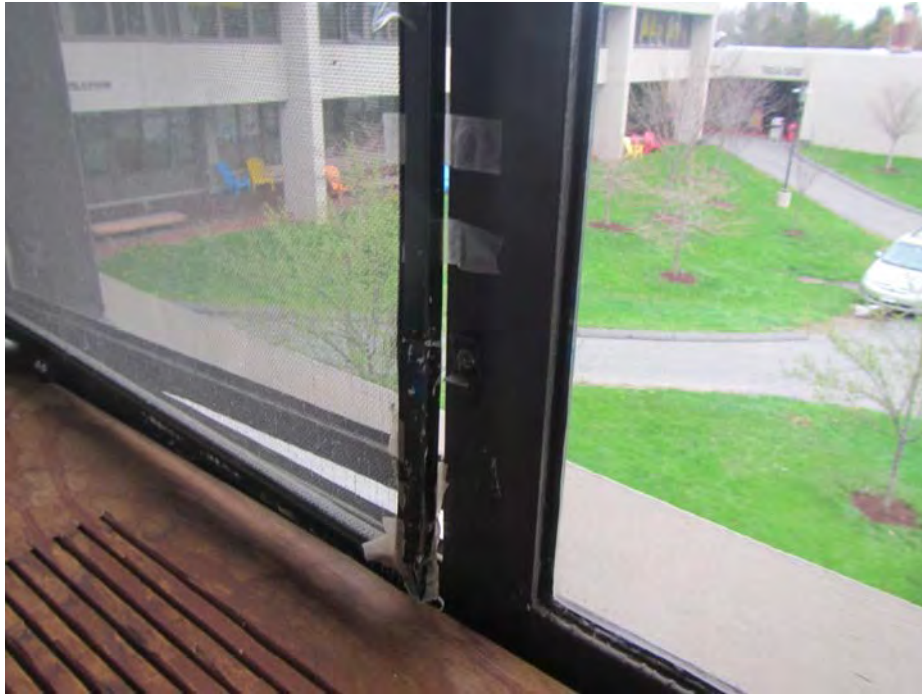
Picture 3

Properly functioning supply and exhaust ventilation are important to dilute and remove indoor air pollutants. Occupants should be encouraged to use open windows and doors for ventilation. Windows and screens were found to need repairs to prevent pest access when windows are open (Picture 3; Table 1).

Screen not attached to window frame

7. Ensure that occupants are aware of procedures to report leaks and other maintenance conditions so that they can be logged and repaired promptly.
8. Make necessary repairs to windows/screens and encourage occupants to open windows to increase ventilation. Ensure windows are closed tightly when rooms are not in use.

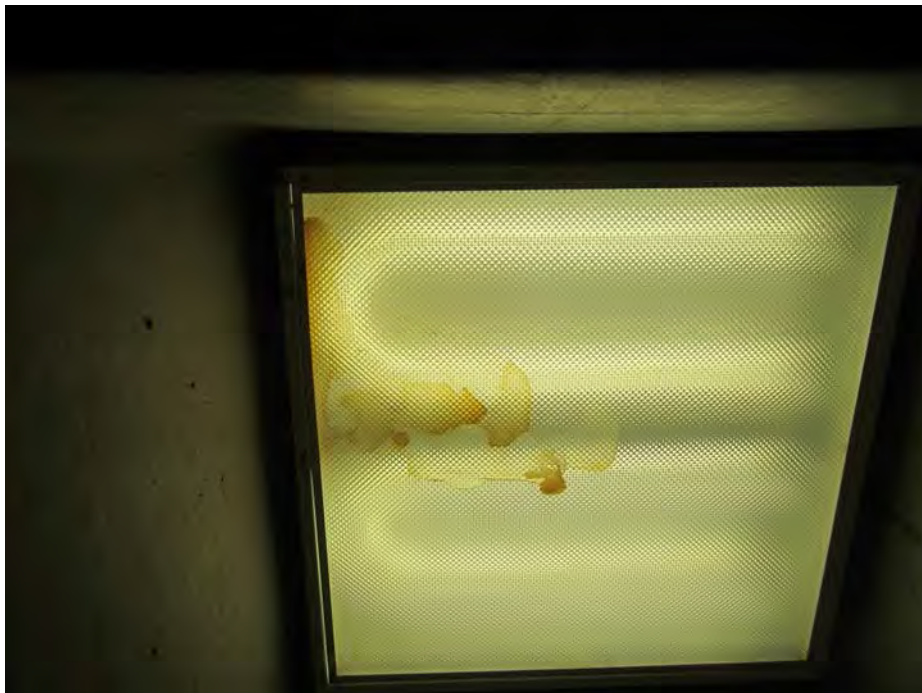
Picture 4

Several active leaks were noted during the visit, specifically in room K213 (main area), the K210 hallway, and the Theatre (Pictures 4 through 6). BCC Facilities reported that a roofing company is in the process of locating and repairing these leaks. BCC Facilities staff use fans to dry occupied areas when leaks occur; however, a slight musty odor was noted in the K210 hallway which may be an indication of chronic water damage. Consideration should be given to replacing this carpet.

Active water leak above light fixture in room K213

1. Continue to ensure all water leaks are fixed promptly and remove any water-damaged porous materials (e.g., ceiling tiles, carpet, gypsum wallboard) that were not dried properly within 24-48 hours.

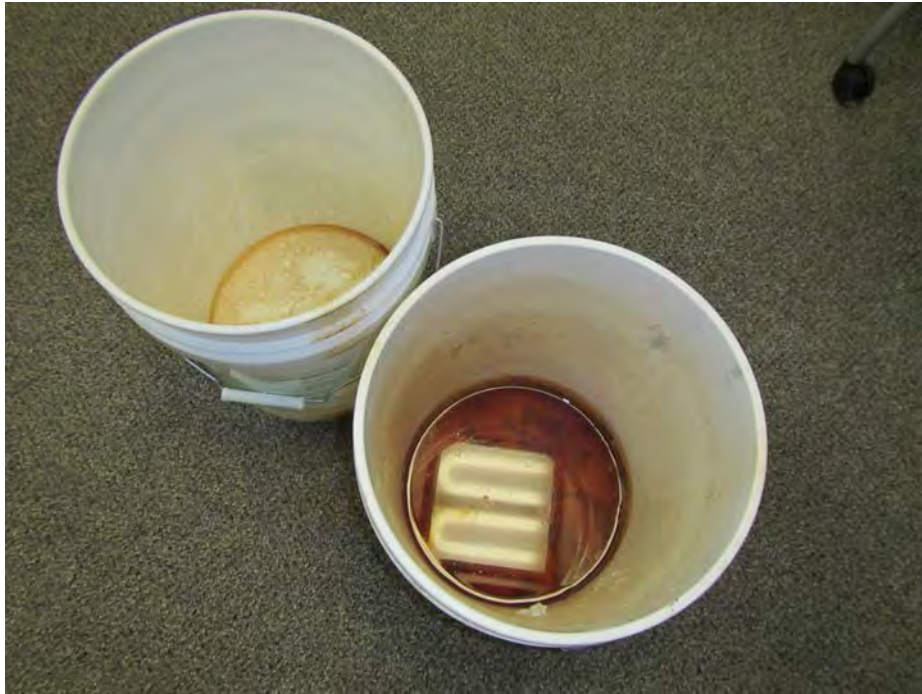
Picture 5

Buckets used in room K213 to catch active water leaks

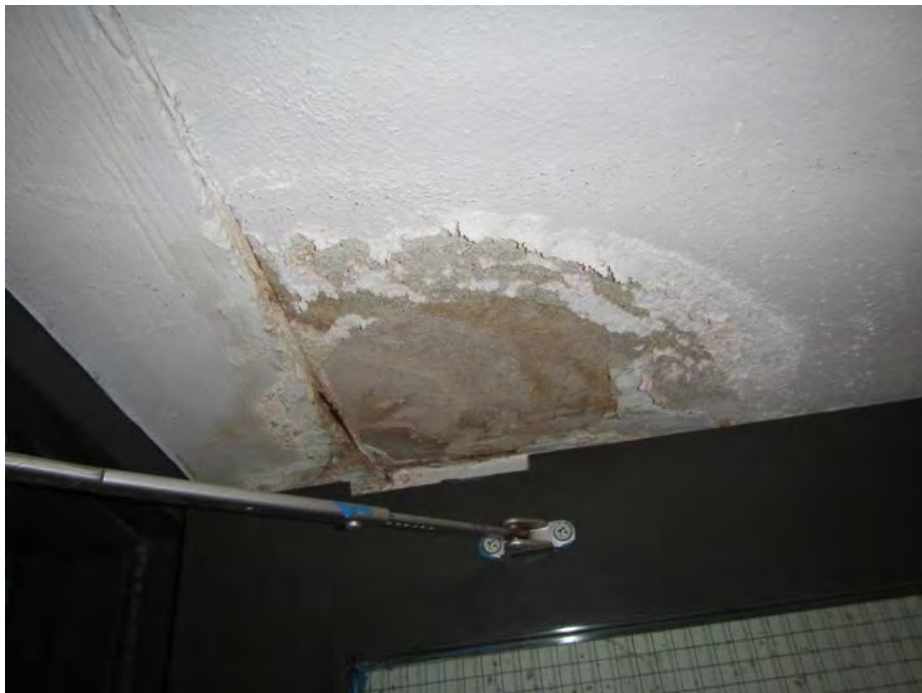
Picture 6

Water-damaged ceiling in K210 hallway

2. Make repairs to the ceiling in K210 hallway after leak has been repaired. Consider replacing the carpeting in this area as it may be water-damaged or mold-colonized.

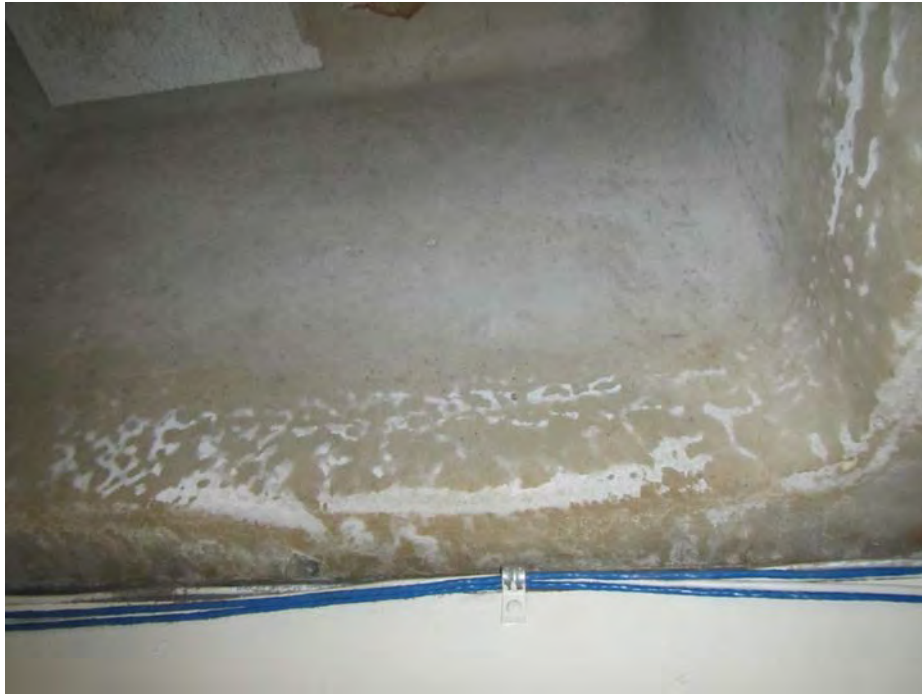
Picture 7

Most of the building components in the KAC are made of concrete which is not conducive to mold growth. BEH/IAQ staff did note accumulations of powdery white material on ceilings in some areas (Picture 7). The white material is called efflorescence; efflorescence is a characteristic sign of water damage to building materials such as brick, mortar, or plaster, but it is not mold growth. As moisture penetrates and works its way through masonry products or concrete, water-soluble compounds dissolve, creating a solution. As the solution moves to the surface of the mortar/concrete, water evaporates, leaving behind white, powdery mineral deposits. This condition indicates that water from the exterior has penetrated into the building. Plaster, concrete, and brick do not typically support mold growth because these materials are not carbon-based; however paint or debris on the wall, or items stored nearby that are moistened, may become mold-colonized. When present, efflorescence can be cleaned.

Efflorescence (white deposits) on concrete ceiling

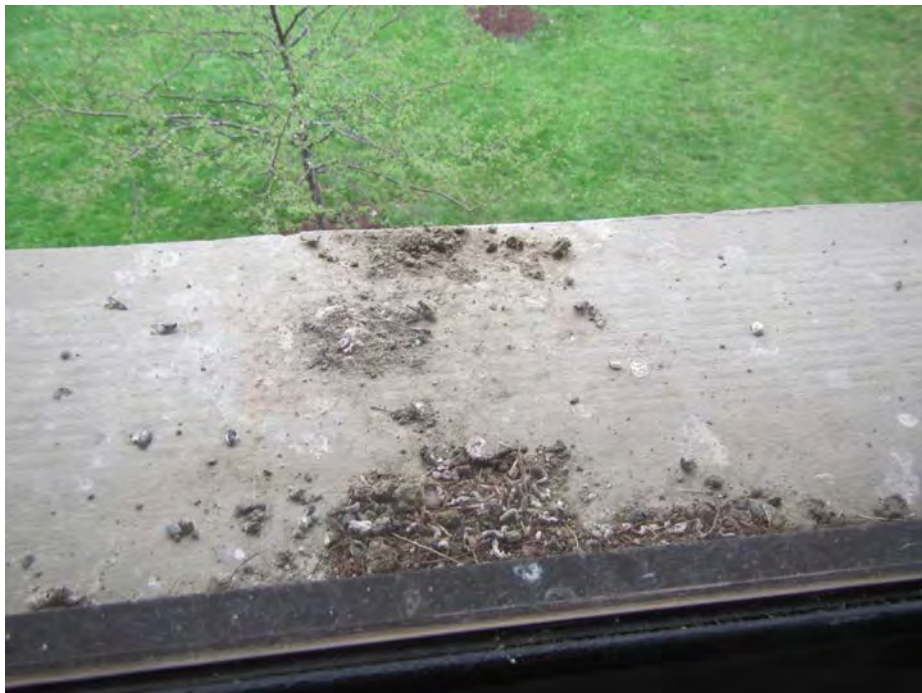
Picture 8

Bird waste and nesting materials were noted on the ledge outside of windows in room K214A (Picture 8). Birds and bird wastes can be sources of allergens and microbial contamination. The bird waste should be removed to avoid entrainment of this material when the windows are opened.

Bird waste and nesting debris outside of window in room K214A

5. Remove any bird waste/nesting materials that are outside of openable windows.
6. Continue to follow MDPH guidelines ([Appendix A](#)) concerning renovations while building is occupied.

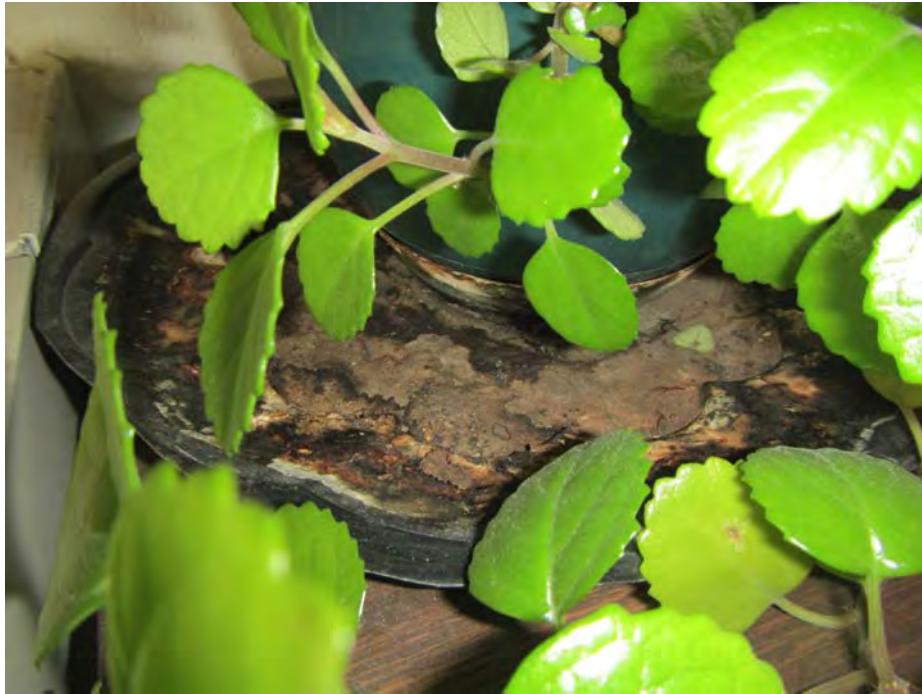
Picture 9

Several areas contained plants, some of which had debris in the drip pans (Picture 9, Table 1). Plants can be a source of pollen and mold, which can be respiratory irritants to some individuals. Plants should be properly maintained and equipped with drip pans to prevent water damage to porous materials. Plants should also be located away from air diffusers to prevent the aerosolization of dirt, pollen, and mold.

Plant showing rotting leaves/debris in drip tray

9. Move plants away from any air streams in classrooms. Avoid over-watering or placing them on porous materials (e.g., cloth, paper) and remove debris from drip pans and clean them periodically.

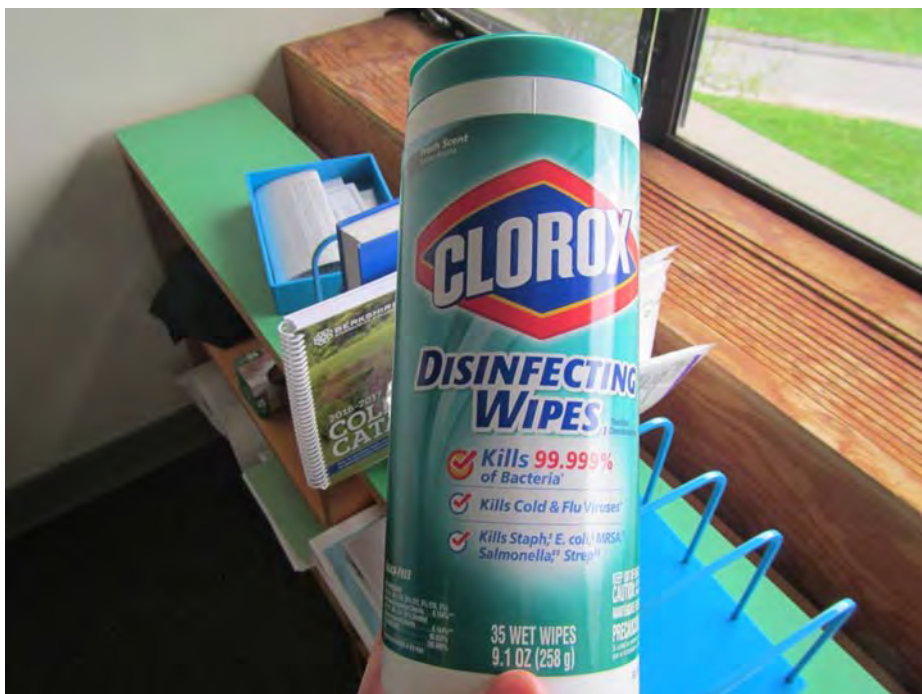
Picture 10

air deodorizers, and dry erase materials in use within the building (Pictures 10 and 11; Table 1). All of these products have the potential to be irritants to the eyes, nose, throat, and respiratory system of sensitive individuals. In particular, dry erase notebooks are used during exams in the Testing Room. Individuals with respiratory sensitivities (e.g., asthma) may experience increased symptoms if a large number of students are using the dry erase markers without adequate ventilation.

VOC-containing cleaning wipes

10. Reduce the use of or eliminate products containing VOC's in classrooms (harsh cleaners/wipes, hand sanitizers, etc.). Ensure adequate ventilation in the testing room during large exam groups which utilize dry erase notebooks.

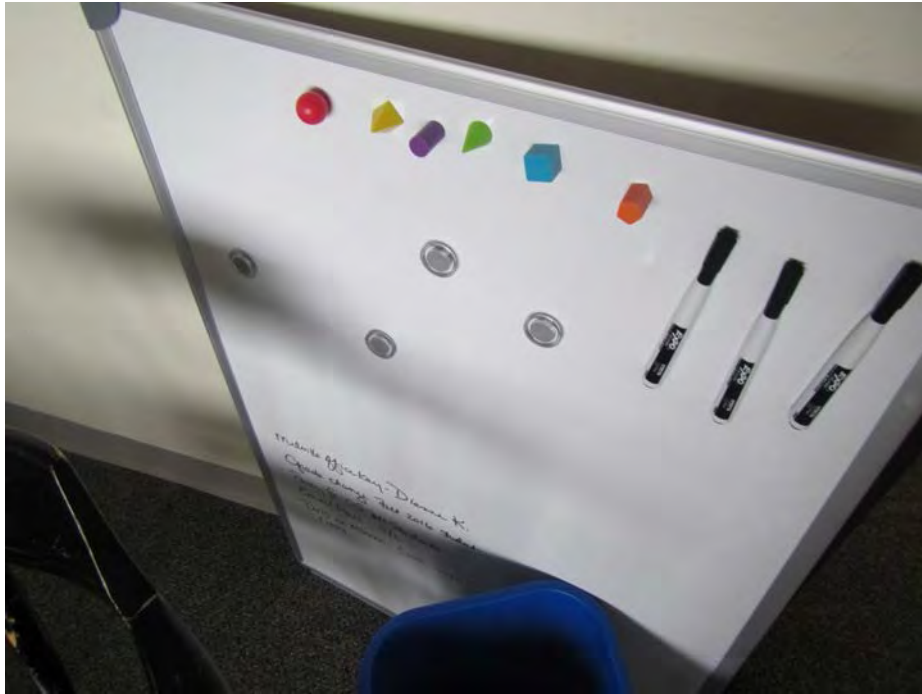
Picture 11

Dry erase materials

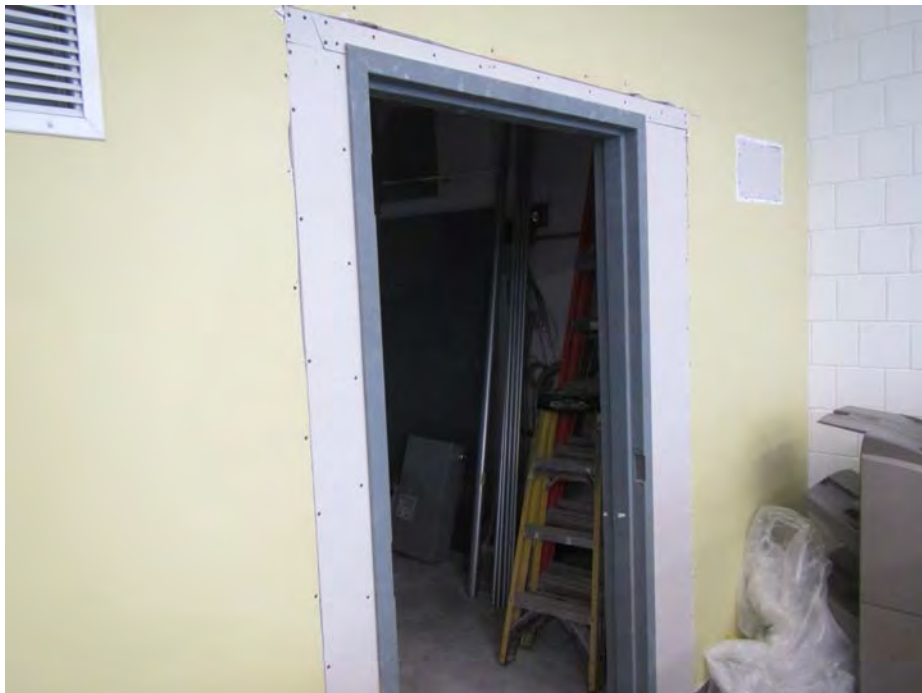
Picture 12

Renovations were being performed in/near the F202 Adjunct Faculty space to build an elevator machine room (Picture 12). Although slight paint odors were noted, no TVOCs were detected, nor were any TVOCs detected when multiple photocopies were made. Because F202 was equipped with mechanical ventilation it had adequate air exchange. The BEH/IAQ program guidance “Methods Used to Reduce/Prevent Exposure to Construction/Renovation Generated Pollutants in Occupied Buildings” is included as [Appendix A](#) for more information on performing these renovations in occupied buildings (MDPH, 2006). At the time of the visit, these guidelines appeared to be being followed.

Elevator machine room renovations near Adjunct Faculty space (F202)
